Asbestos Management Survey
Savernake Court
Savernake Street
Swindon
SN1 3LX

Date: 24th June 2024 Expiry Date: 24th June 2025 Prepared by K Howell Reviewed by C Jelfs

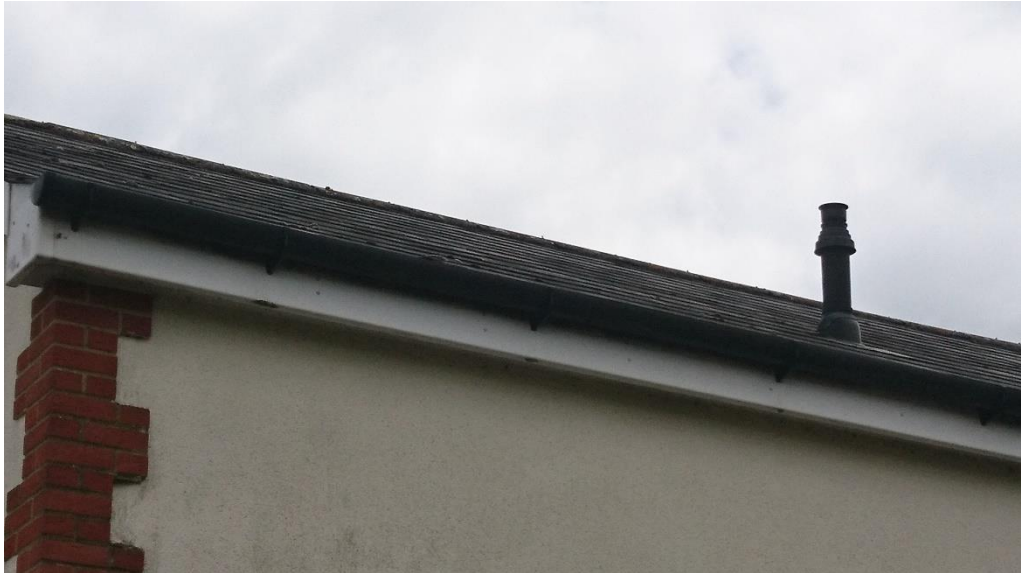
Client			
Survey Address	Savernake Court Savernake Street Swindon SN1 3LX		
Location/Item	E01 Externals cement roof tiles		
Reference Number	3		
Sample Number	PTCA		
Photo Details

Risk Matrix			
Asbestos Type	1	Product Use	1
Condition	1	Surface Treatment	1
Material Risk	4	Action	Mark and Manage
Priority Assessment			
Accessibility			
Amount/Extent	120M2		
Surveyors Notes

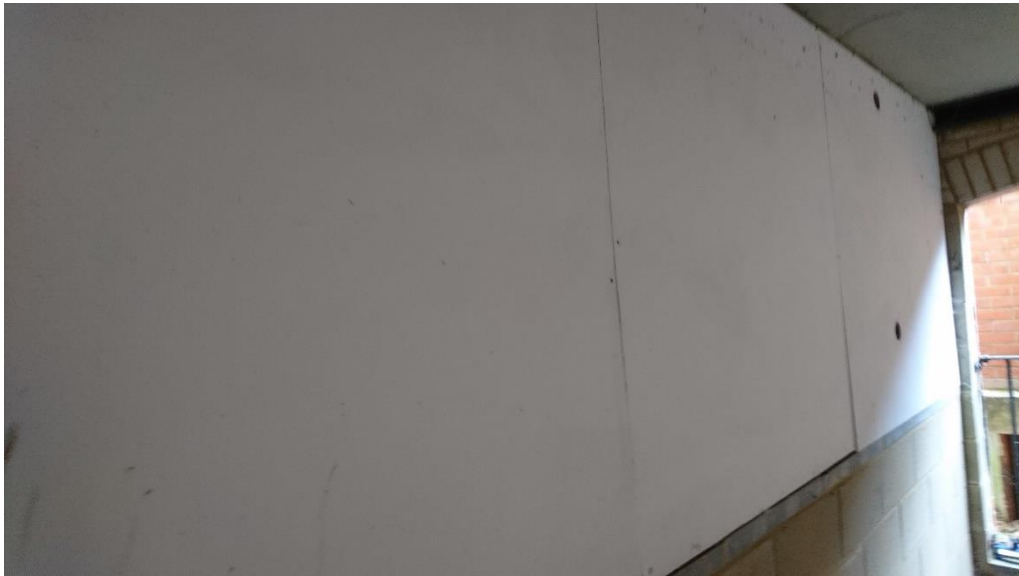
Client	
Survey Address	Savernake Court Savernake Street Swindon SN1 3LX
Location/Item	007 Carpark insulating board to wall
Reference Number	1
Sample Number	001
Photo Details
