# COMBINED FIRE AND HEALTH & SAFETY RISK ASSESSMENT.

Address of premises:	1-11 Savernake Court Savernake Street Swindon SN1 3XL
Responsible Person:	Savernake Court Management Company Limited
Duty Holder:	Block Management Limited
Person(s) consulted:	No occupier or other relevant person available to consult.
Assessor:	Rob Cockburn
Report validated by:	John Godfrey, GIFireE.
Date of fire risk assessment:	23 <sup>rd</sup> October 2024/ Reviewed October 2025
Date of previous fire risk assessment:	N/K
Suggested date for review:	October 2025

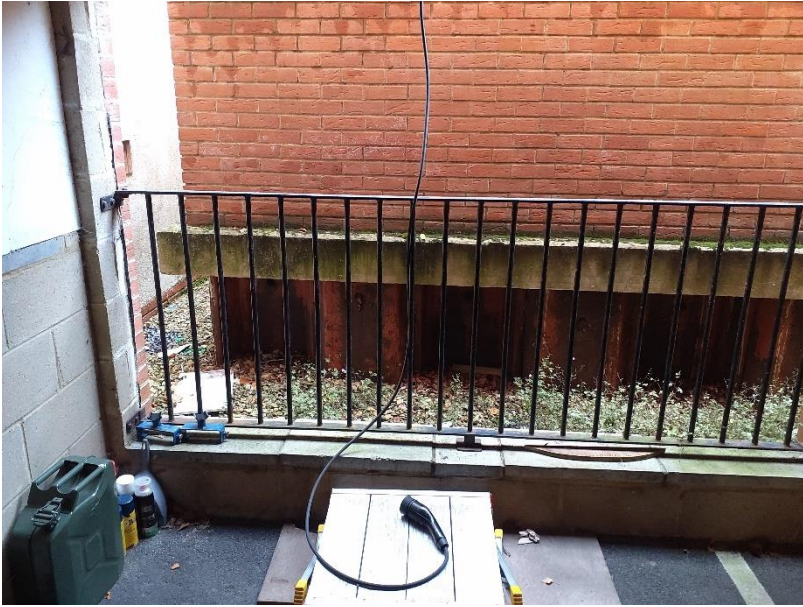
Item	Recommendation	Priority	Timescale
01	<p>It was noted during this fire risk assessment that there was an EV charge cable in the enclosed ground floor carpark.</p> <p>It is recommended that the RP consult Guidance Document RC59: Recommendations for fire safety when charging electric vehicles and compliance with all sections should be sought. This may require some intrusive passive fire surveys and some alterations to the fire alarm system, together with remote electrical isolation. Specialist advice therefore may be required from qualified contractors.</p>

Action required  
This action is not permitted. DH have informed owners this action is not permitted.

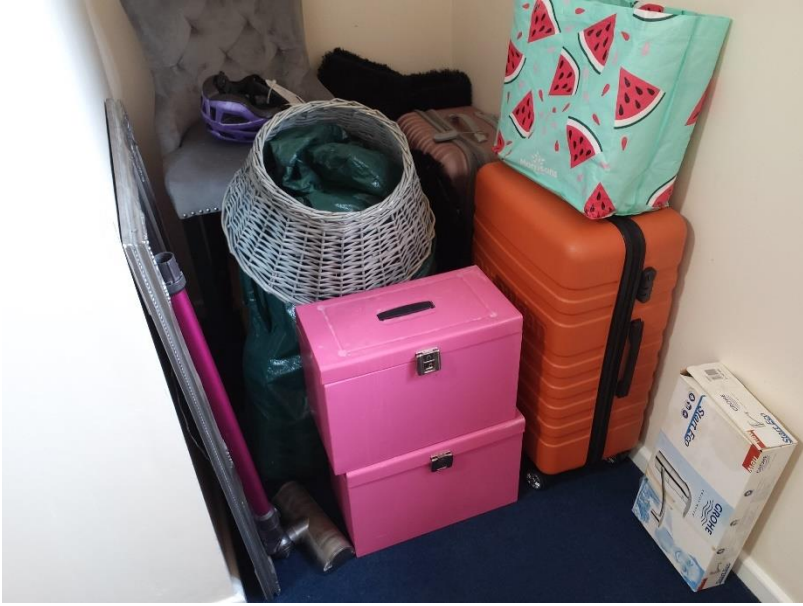
<p>03</p>	<p>Housekeeping was found to be of a poor standard at the time of this assessment with the communal areas, riser cupboards and escape routes congested with residents' possessions and storage. It is recommended that the client arrange for the communal areas and riser cupboards to be cleared as a priority and all residents reminded of the importance of maintaining sterile communal areas, riser cupboards and escape routes.</p>

<p>2</p>	<p>B</p>	<p>Ongoing action required DH inspect communal area and ticket items for removal.  Residents are reminded of sterile area policy via notice board</p>
<p>04</p>	<p>All contractors employed by the client must supply risk assessments and method statements prior to working. It is recommended that the client give all contractors induction training prior to commencing work, which should include emergency procedures. Additionally, the client should arrange to conduct a post work inspection of the work area to ensure all works have been completed satisfactorily and safely, with no residual hazards present that could compromise the fire safety of the premises.</p>	<p>3</p>	<p>C</p>	<p>Ongoing action required DH action as required</p>

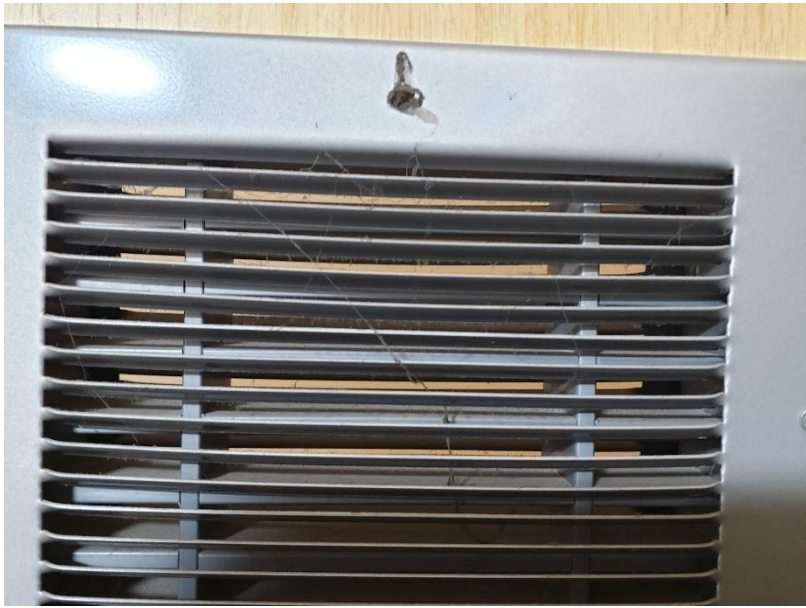
05	<p>It was noted during this fire risk assessment that multiple vents on the riser doors and intake doors on all floors and within the carpark did not appear to be intumescent vents. This could allow smoke and fire to easily pass into the means of escape which could stop/impede persons escape. It is therefore recommended that the RP instructs a suitably qualified and competent contractor to inspect all the vents to ensure they are intumescent vents. Any deficiencies found should be replaced as a priority in order to protect the means of escape as per Home Office Fire Safety (England) Regulations 2022 – Fire Door Guidance Section 6.12.</p>

1	B
----	---	---	---

Action Complete

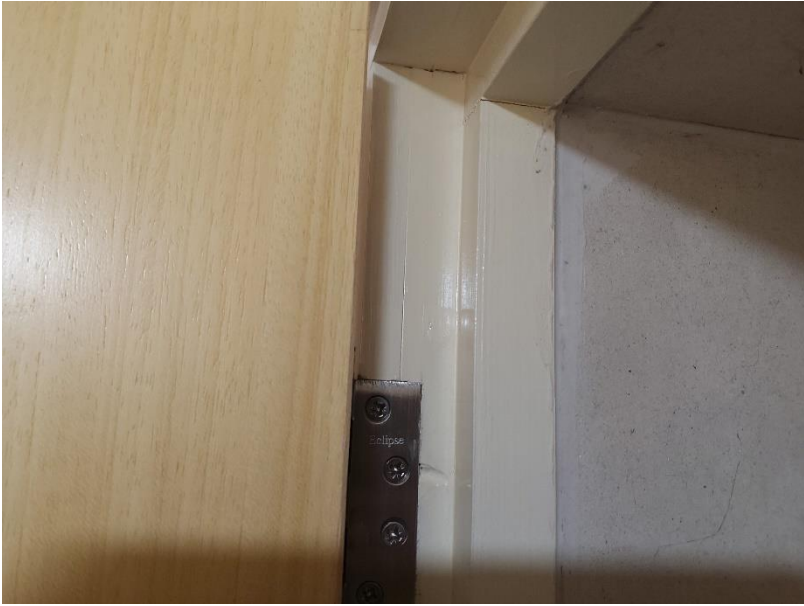
06	<p>It was noted during this fire risk assessment that the lobby doors on all riser doors on all floors had painted seals and no cold smoke seals and no smoke seals installed within the gas and electrical intake cupboard door located in the carpark. This could affect the integrity of the smoke seal/doorset which could allow smoke to spread into the means of escape. It is therefore recommended that the RP instructs a suitably qualified and competent contractor to replace the smoke seals with new combined cold smoke and intumescent seals as per Home Office Fire Safety (England) Regulations 2022 – Fire Door Guidance Section 6.7F.</p>

2	B
----	---	---	---

Action complete

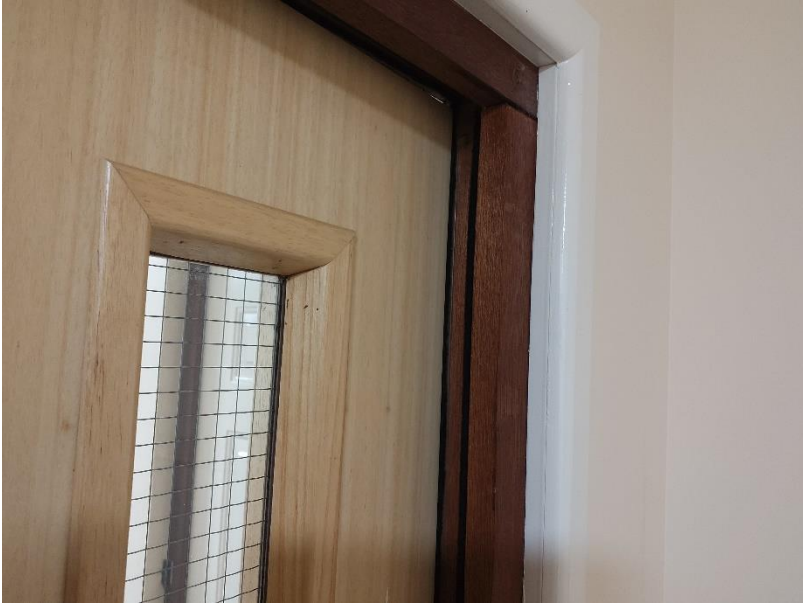
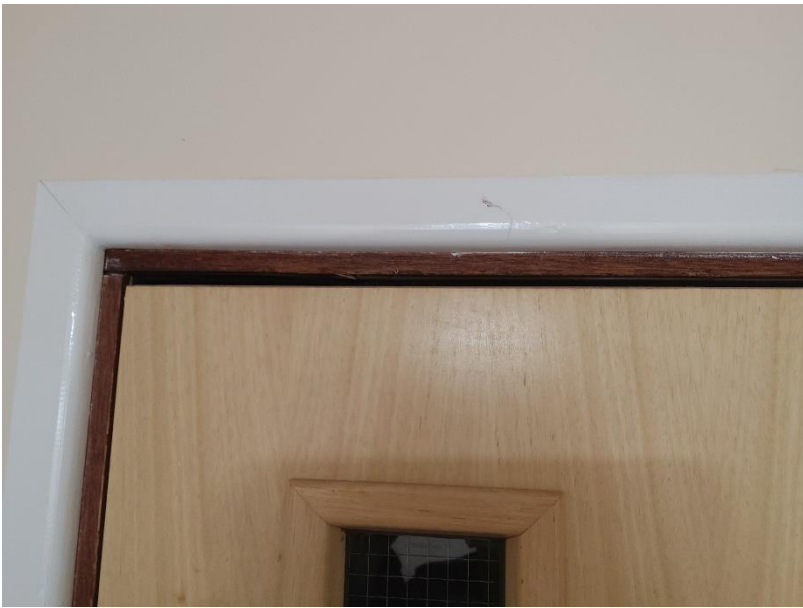
<p>07</p>	<p>It was noted during this fire risk assessment that the lobby doors to flats 8-11, flat 7, flats 3-6 and flat 1 had gaps larger than 4mm or less than 2mm causing the door to not fully self-close. This could allow smoke and fire to spread into the means of escape. It is therefore recommended that the RP instructs a suitably qualified and competent contractor to rehang the door to achieve gaps which are no less than 2mm and no more than 4mm. If this cannot be achieved it is further recommended that the RP instructs the contractor to replace the doors with new FD30s fire doors complete with three grade 13 hinges, a combined cold smoke and intumescent seal, an overhead closer and "Fire Door Keep Shut" signage as per Home Office Fire Safety (England) Regulations 2022: Fire Door Guidance Section 6.7C.</p>

<p>2</p>	<p>B</p>
-----------	---	----------	----------

Action complete  
To be monitored

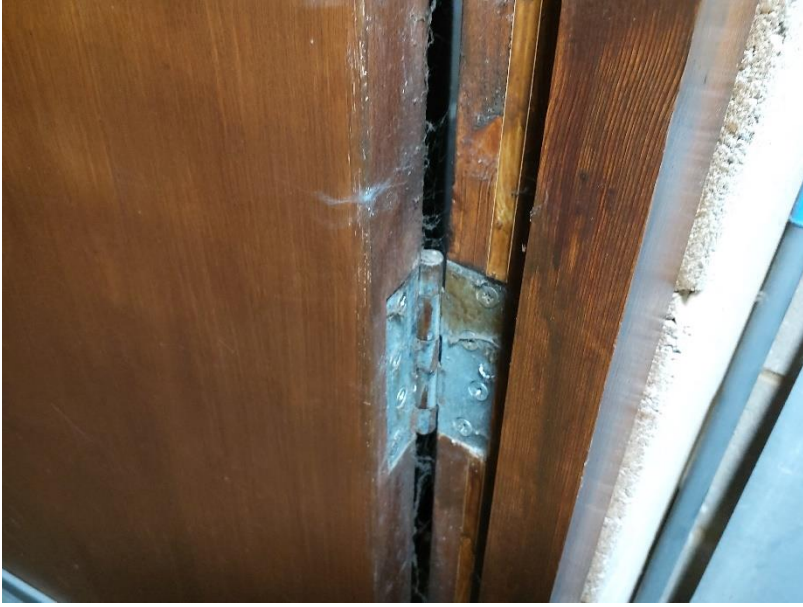
<p>08</p>	<p>It was noted during this fire risk assessment that the electrical and gas intake cupboard doors in the carpark had non-fire rated hinges which could cause the door to fall from its leaf in the event of a high temperature fire. It is therefore recommended that the RP instructs a suitably qualified and competent contractor to rehang each lobby door on three grade 13 hinges in order to maintain the integrity of the doorset and protect the means of escape.</p>

<p>3</p>	<p>B</p>	<p>Action complete</p>
<p>09</p>	<p>As per section 33.2 of Fire Safety in Purpose-Built Block of Flats a type 1 fire risk assessment requires us to conduct a fire door survey on a sample of flat front doors. The door to flat 10 was surveyed during this sample which confirmation of the fire resistance could not be confirmed due to no certification sticker being present. It is essential that each flat entrance door is a suitable fire door, providing a minimum of thirty minutes fire resistance, hung on three grade 13 hinges and having a functioning self-closing device fitted that positively closes the door on the latch, together with smoke and intumescent seals. It is recommended therefore that the RP instruct a suitably qualified and competent contractor to conduct a fire door inspection to all flat entrance doors and communal area doors providing advice on suitability. Any shortcomings identified by this inspection should be addressed as a priority by upgrading or replacing the door. Flat entrance doors, communal area doors, the seals and the self-closing devices should then be subjected to an annual inspection and maintenance schedule.</p>	<p>1</p>	<p>B</p>	<p>Ongoing Action required Flat entrance doors inspected May 2025  Inspection scheduled in accordance with current legislation. DH provide safety notice and via website</p>

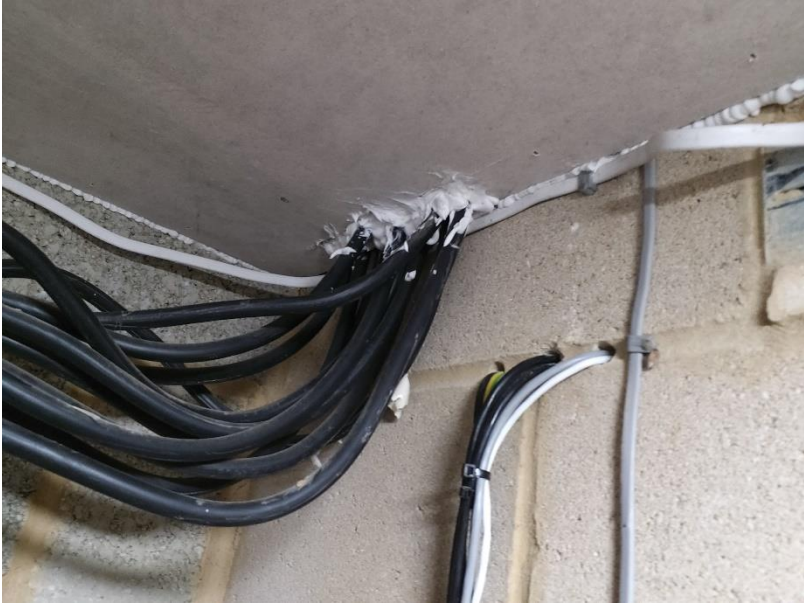
11	<p>It was noted during this fire risk assessment that there was an overuse of intumescent sealant within the electrical intake cupboard within the carpark. Intumescent sealant is used to seal other fire-resistant materials and should not be used as the main fire resisting compound due to the inconsistent viscosity causing the integrity to fail at different time frames within a fire. It is therefore recommended that the RP instructs a suitably qualified and competent contractor to replace this overuse of sealant with a compound capable of providing a consistent minimum of 30 minutes fire resistance (like pink plasterboard) in order to protect the means of escape from smoke and fire.</p>

2	C
----	--	---	---

Action complete

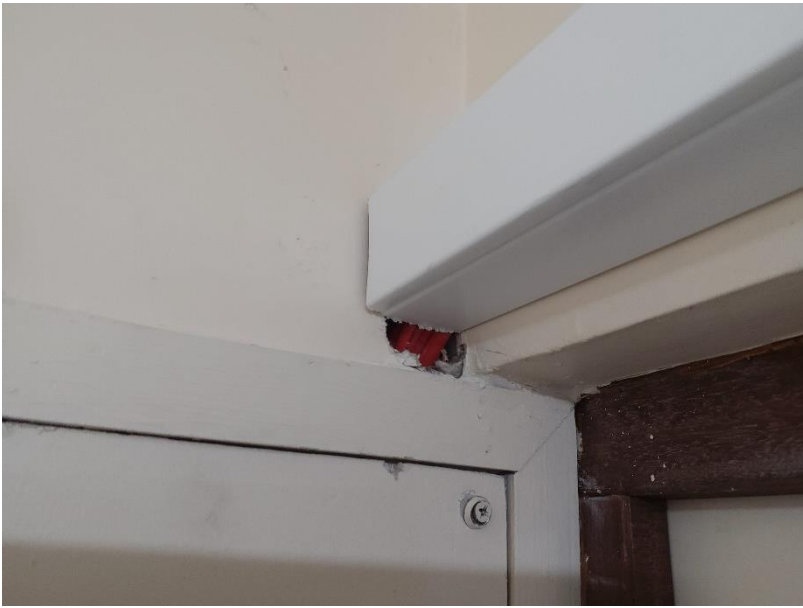
12	<p>It was noted during this fire risk assessment that there were breaches in the compartmentation adjacent to flat 5 and the gas and electrical intake cupboard located in the carpark. This could allow smoke and fire to spread into the means of escape or undetected throughout the premises which could contradict the stay put policy and/or impede persons escape from the building. It is therefore recommended that the RP instructs a suitably qualified and competent contractor to repair the breaches with a suitable compound capable of providing a minimum of 30 minutes fire resistance in order to protect the means of escape.</p>

2	B
----	---	---	---

Action complete
